**Flood Control Project Maintenance  
Levee Inspections****2015 Channel Summary Report****Overall Unit and Item Ratings****Fairfield Suisun Sewer District**

**Flood Control Project Maintenance****Unit Cover Sheet****2015 Channel Inspection Results****Fairfield Suisun Sewer District**

**Levee Inspection Report By Mile - Channel 2015**

**Fairfield Suisun Sewer District**

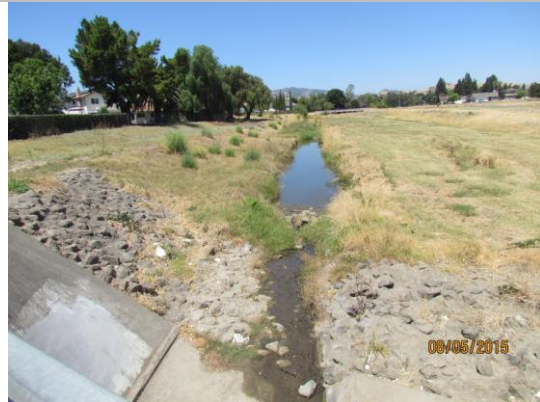
Photo 1 of 2 : CH\_2015\_NA0035\_15\_1\_20150817\_00045.jpg

Inspector Comments: Minimal, scattered obstructions or vegetation. The flow is not impeded.

View of Laurel Creek looking upstream. Summer 2015.

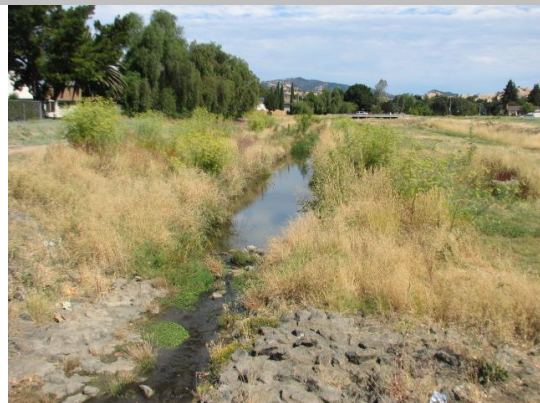
Photo 2 of 2 : CH\_2015\_NA0035\_15\_1\_20150612\_00001.jpg

A view looking upstream from Cement Hill Rd. Summer 2014

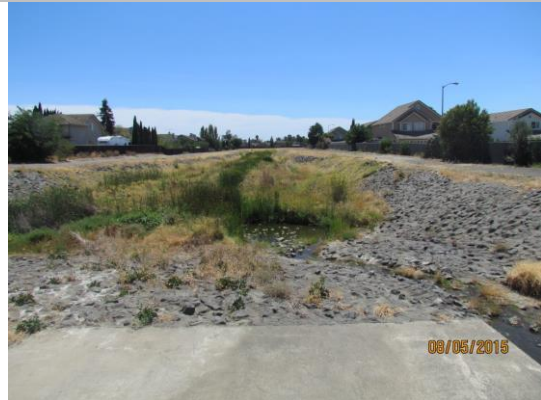
Photo 1 of 2 : CH\_2015\_NA0035\_15\_6\_20150817\_00046.jpg

Rating **	A	Issue No.	6	GPS Lat/Long
Issue Type +	Ma	Location *		38.279937 °
Category	Rivers, Channels & Designated Flood			-122.018353 °
Item	Vegetation & Obstructions			
DWR ID	DWR_NA0035_15_c_2012_6			
Action/Comments				
Inspector Comments: Minimal, scattered obstructions or vegetation. The flow is not impeded.

Looking downstream from Cement Hill Rd. Summer 2015.

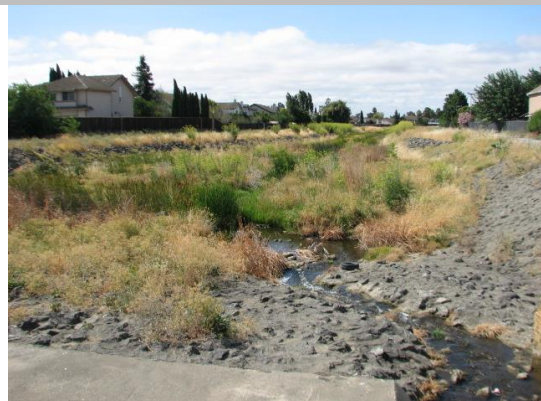
Photo 2 of 2 : CH\_2015\_NA0035\_15\_6\_20150612\_00009.jpg

A view looking downstream from Cement Hill Rd. Summer 2014

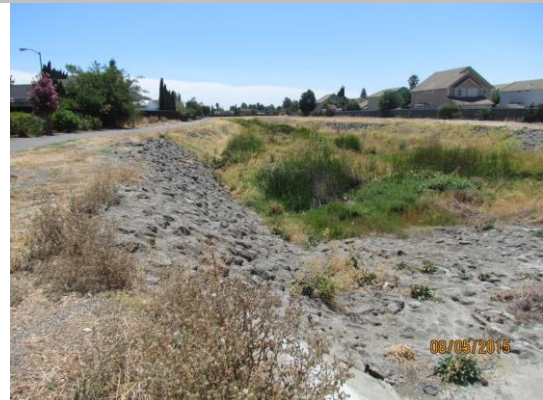
Photo 1 of 1 : CH\_2015\_NA0035\_15\_9\_20150817\_00047.jpg

Rating **	A	Issue No.	9	GPS Lat/Long
Issue Type +	Ma	Location *		38.279937
Category	Rivers, Channels & Designated Flood			-122.018354
Item	Revetments			
DWR ID	DWR_NA0035_15_c _ 2012_9			
Action/Comments				
Inspector Comments: Existing riprap protection is properly maintained and is undamaged. Riprap clearly visible.

View of revetment on the left bank looking downstream. Summer 2015.

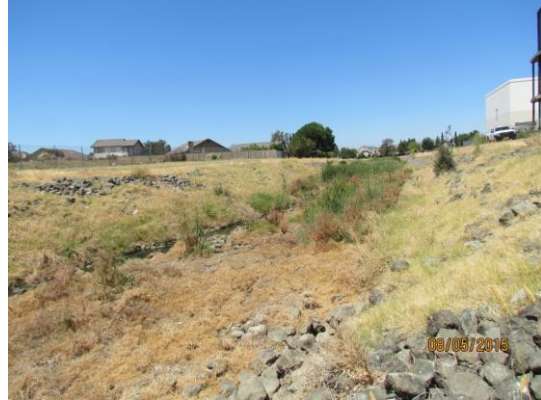
Photo 1 of 2 : CH\_2015\_NA0035\_15\_11\_20150817\_00048.jpg

Rating **	A	Issue No.	11	GPS Lat/Long
Issue Type +	Ma	Location *		38.272637 °
Category	Rivers, Channels & Designated Flood			-122.016114 °
Item	Vegetation & Obstructions			
DWR ID	DWR_NA0035_15_c_2012_11			
Action/Comments				
Inspector Comments: Minimal, scattered obstructions or vegetation. The flow is not impeded.

Looking upstream from Air Base Pkwy. Summer 2015.

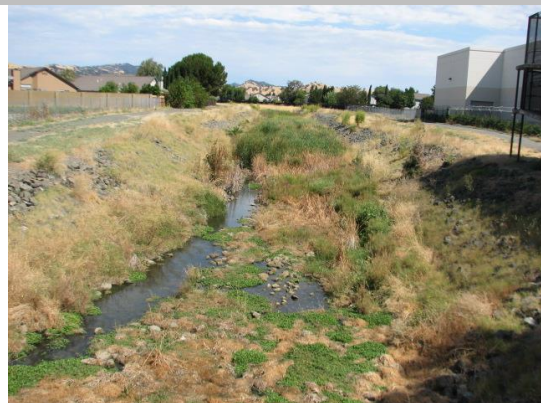
Photo 2 of 2 : CH\_2015\_NA0035\_15\_11\_20150612\_00011.jpg

Looking upstream from Air Base Pkwy. Summer 2014

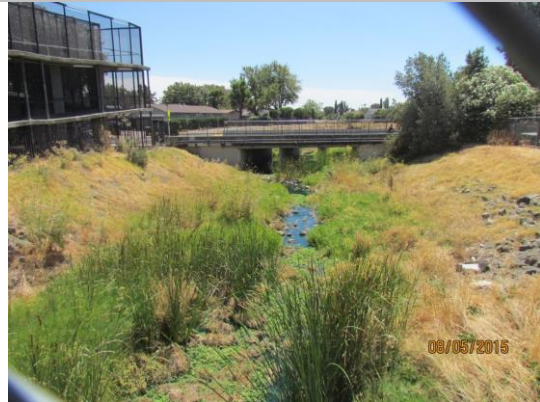
Photo 1 of 2 : CH\_2015\_NA0035\_15\_16\_20150817\_00049.jpg

Inspector Comments: Minimal, scattered obstructions or vegetation. The flow is not impeded.

Looking downstream from Air Base Pkwy. Summer 2015.

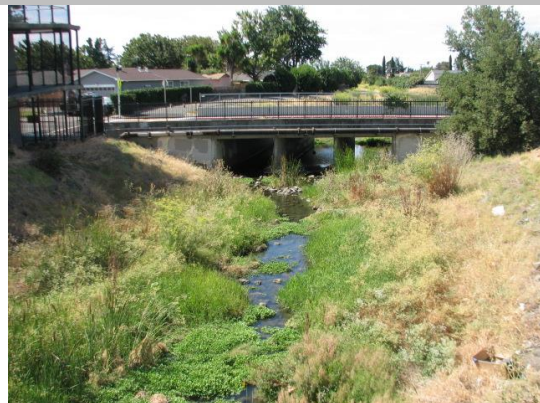
Photo 2 of 2 : CH\_2015\_NA0035\_15\_16\_20150612\_00013.jpg

A view looking towards Nightingale from Air Base Pkwy. Summer 2014

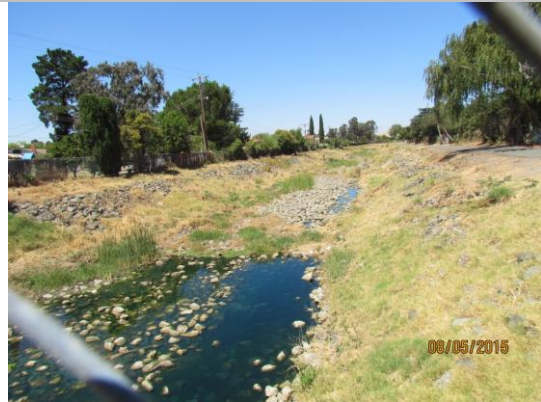
Photo 1 of 2 : CH\_2015\_NA0035\_15\_21\_20150817\_00050.jpg

Inspector Comments: Minimal, scattered obstructions or vegetation. The flow is not impeded. The palm trees should be removed.

Looking upstream from Meadowlark Dr. Summer 2015.

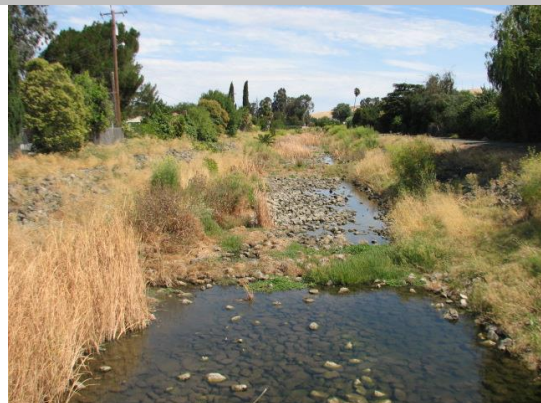
Photo 2 of 2 : CH\_2015\_NA0035\_15\_21\_20150612\_00015.jpg

Looking upstream from Meadowlark Dr. Summer 2014

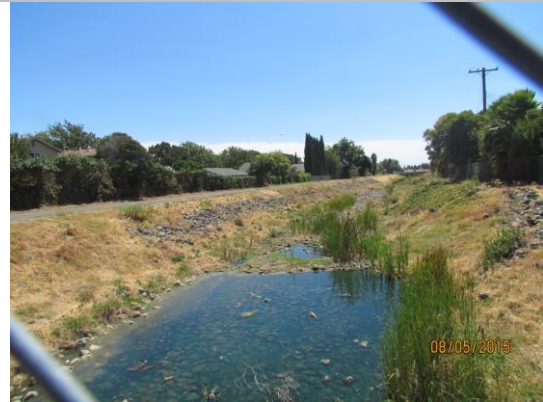
Photo 1 of 2 : CH\_2015\_NA0035\_15\_26\_20150817\_00051.jpg

Inspector Comments: Minimal, scattered obstructions or vegetation. The flow is not impeded.

Looking downstream from Meadowlark Dr. Summer 2015.

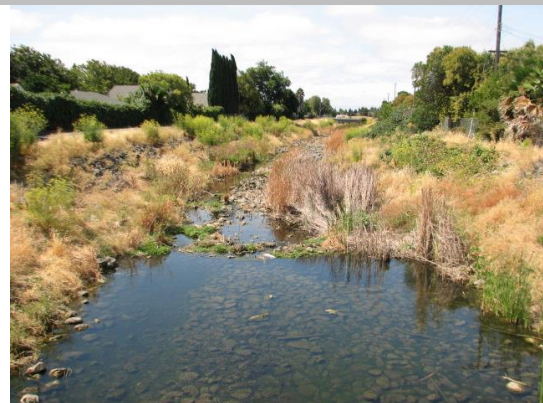
Photo 2 of 2 : CH\_2015\_NA0035\_15\_26\_20150612\_00017.jpg

A view looking downstream from Meadowlark Dr. Summer 2014

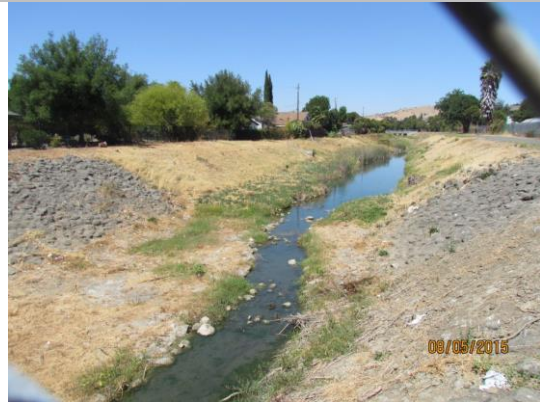
Photo 1 of 2 : CH\_2015\_NA0035\_15\_31\_20150817\_00053.jpg

Rating **	A	Issue No.	31	GPS Lat/Long
Issue Type +	Ma	Location *		38.265401
Category	Rivers, Channels & Designated Flood			-122.018316
Item	Vegetation & Obstructions			
DWR ID	DWR_NA0035_15_c _ 2012_31			
Action/Comments				
Inspector Comments: Minimal, scattered obstructions or vegetation. The flow is not impeded. The palm trees should be removed.

Looking upstream from E. Tabor Ave. Woody vegetation has been removed. Summer 2015.

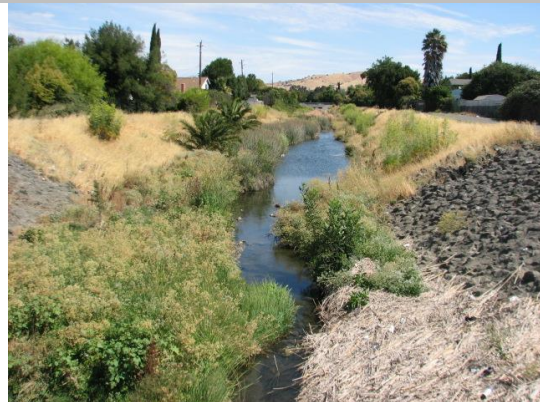
Photo 2 of 2 : CH\_2015\_NA0035\_15\_31\_20150612\_00021.jpg

A view looking upstream from E. Tabor Ave. Summer 2014 Woody vegetation needs to be removed.

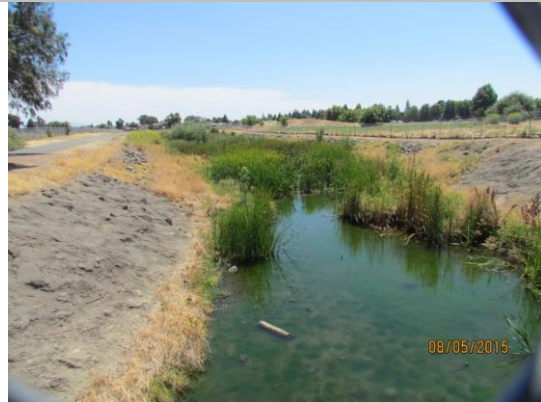
Photo 1 of 2 : CH\_2015\_NA0035\_15\_36\_20150817\_00055.jpg

Rating **	A	Issue No.	36	GPS Lat/Long
Issue Type +	Ma	Location *		38.265401 °
Category	Rivers, Channels & Designated Flood			-122.018316 °
Item	Vegetation & Obstructions			
DWR ID	DWR_NA0035_15_c _ 2012_36			
Action/Comments				
Inspector Comments: Minimal, scattered obstructions or vegetation. The flow is not impeded.

Looking downstream from E. Tabor Ave. Summer 2015.

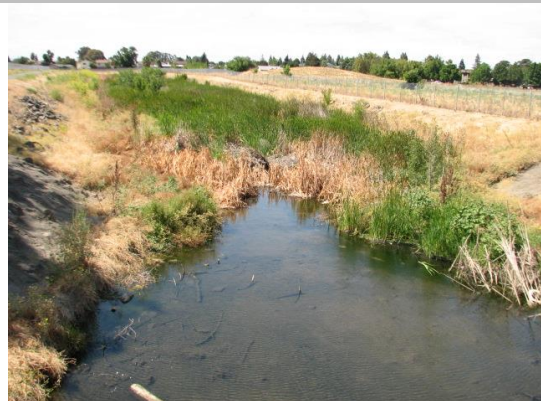
Photo 2 of 2 : CH\_2015\_NA0035\_15\_36\_20150612\_00022.jpg

Looking downstream from E. Tabor Ave. Summer 2014

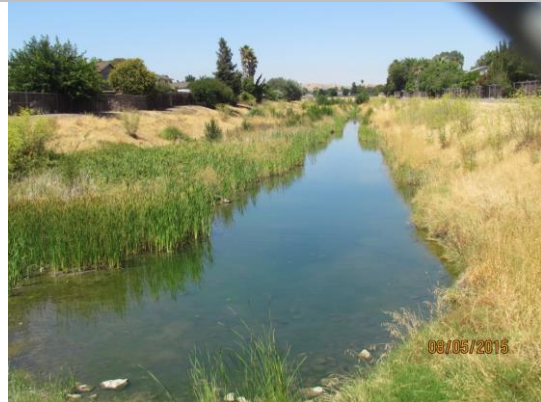
Photo 1 of 2 : CH\_2015\_NA0035\_15\_41\_20150817\_00056.jpg

Rating **	A	Issue No.	41	GPS Lat/Long
Issue Type +	Ma	Location *		38.259229 °
Category	Rivers, Channels & Designated Flood			-122.017713 °
Item	Vegetation & Obstructions			
DWR ID	DWR_NA0035_15_c_2012_41			
Action/Comments				
Inspector Comments: Minimal, scattered obstructions or vegetation. The flow is not impeded.

Looking upstream rom Matthew Rd. Summer 2015.

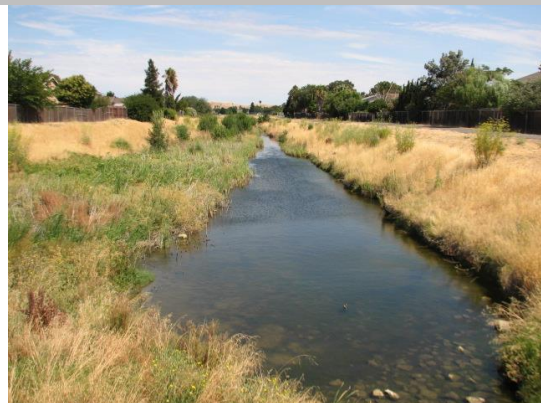
Photo 2 of 2 : CH\_2015\_NA0035\_15\_41\_20150612\_00024.jpg

Looking upstream from Matthew Rd. Summer 2014

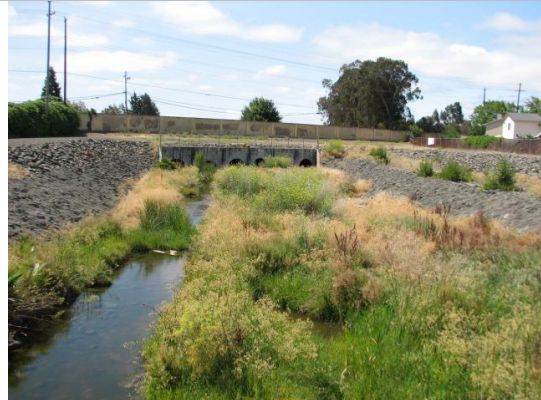
Photo 2 of 2 : CH\_2015\_NA0035\_15\_46\_20150612\_00029.jpg

Rating **	A	Issue No.	46	GPS Lat/Long
Issue Type +	Ma	Location *		38.259230 °
Category	Rivers, Channels & Designated Flood			-122.017714 °
Item	Vegetation & Obstructions			
DWR ID	DWR_NA0035_15_c _ 2012_46			
Action/Comments				
Inspector Comments: This area is the same as upstream Railroad Avenue. I recommend the removal of the baby palm trees.

Looking downstream towards the five pipes that go under the railroad from Matthews Rd. Summer 2014

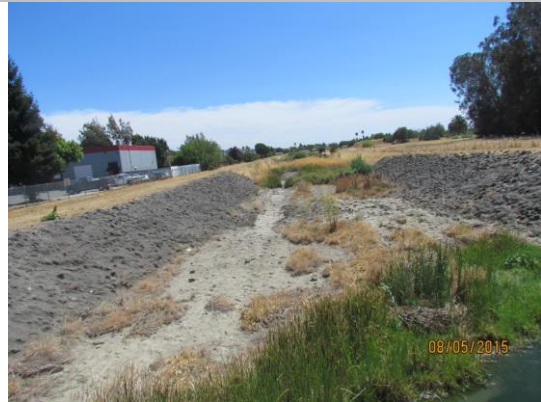
Photo 1 of 2 : CH\_2015\_NA0035\_15\_56\_20150817\_00059.jpg

Inspector Comments: Minimal scattered obstruction or vegetation. The flow is not impeded.

Looking downstream from Railroad Ave. Summer 2015.

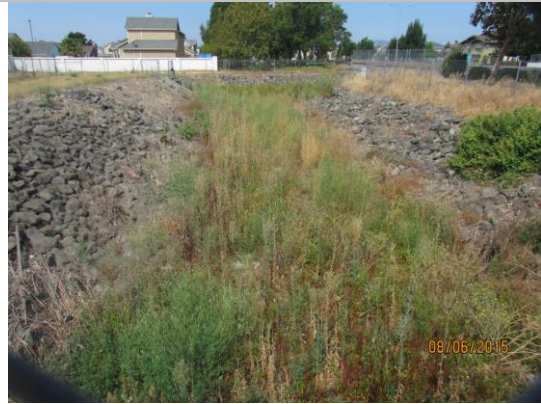
Photo 1 of 2 : CH\_2015\_NA0035\_15\_61\_20150817\_00060.jpg

Rating **	A	Issue No.	61	GPS Lat/Long
Issue Type +	Ma	Location *		38.253525 °
Category	Rivers, Channels & Designated Flood			-122.019984 °
Item	Vegetation & Obstructions			
DWR ID	DWR_NA0035_15_c_2012_61			
Action/Comments				
Inspector Comments: Minimal scattered obstructions or vegetation. The flow is not impeded.

Looking upstream from Sunset Ave. Summer 2015.

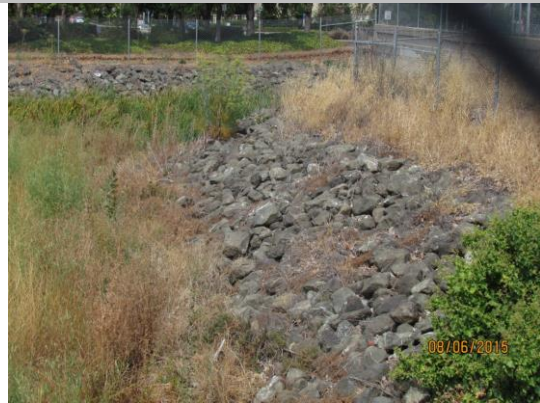
Photo 1 of 2 : CH\_2015\_NA0035\_15\_64\_20150817\_00062.jpg

Inspector Comments: Riprap displacement or scouring activity. Unwanted vegetation must be cleared and sprayed with an appropriate herbicide.

View of the revetment on the left bank looking upstream. Summer 2015.

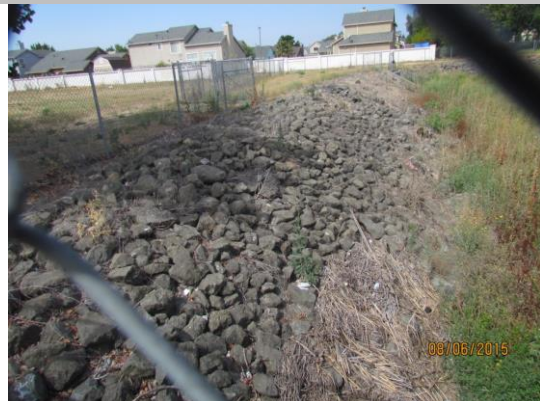
Photo 2 of 2 : CH\_2015\_NA0035\_15\_64\_20150817\_00061.jpg

View of the revetment on the right bank looking upstream. Summer

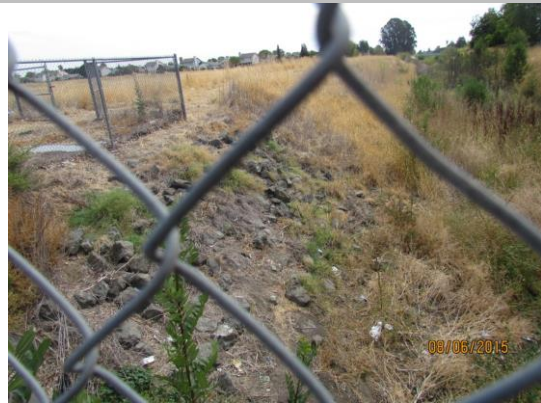
Photo 1 of 2 : CH\_2015\_NA0035\_15\_69\_20150817\_00066.jpg

Inspector Comments: No riprap displacement or scouring activity.

View of the revetment on the left bank looking downstream from Sunset Ave. Summer 2015.

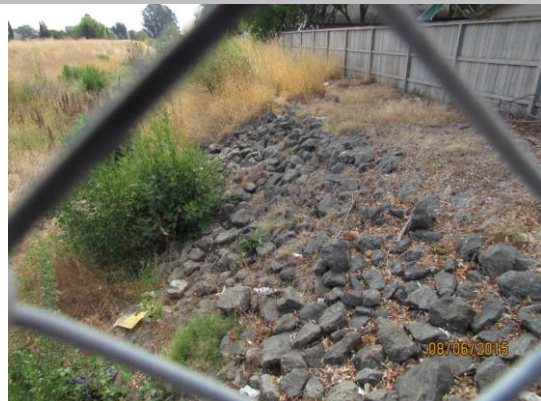
Photo 2 of 2 : CH\_2015\_NA0035\_15\_69\_20150817\_00065.jpg

View of the revetment on the right bank looking downstream from Sunset Ave. Summer 2015.

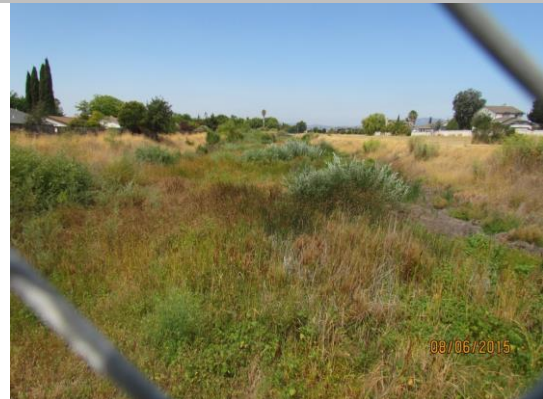
Photo 1 of 3 : CH\_2015\_NA0035\_15\_71\_20150817\_00067.jpg

Check Point / View				
Blossom Rd / Up				
Rating **	M	Issue No.	71	GPS Lat/Long
Issue Type +	Ma	Location *		38.253382 °
Category	Rivers, Channels & Designated Flood			-122.014862 °
Item	Vegetation & Obstructions			
DWR ID	DWR_NA0035_15_c _ 2012_71			
Action/Comments				
Inspector Comments: Vegetation growth, cat tails, bushes, or saplings block 25% of the channel.

Looking upstream from Blossom Rd. Summer 2015.

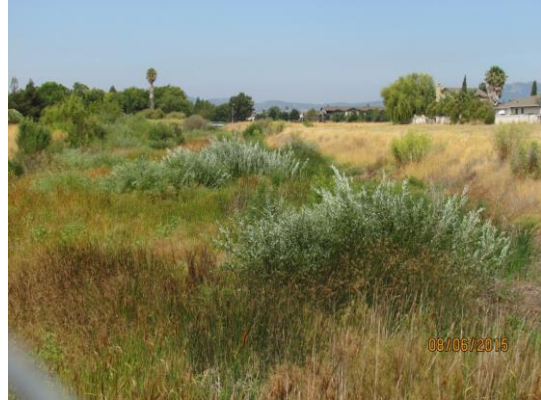
Photo 2 of 3 : CH\_2015\_NA0035\_15\_71\_20150817\_00068.jpg

Inspector Comments: Vegetation growth, cat tails, bushes, or saplings block 25% of the channel.

Suggest removal of woody vegetation of upstream channel. Summer 2015.

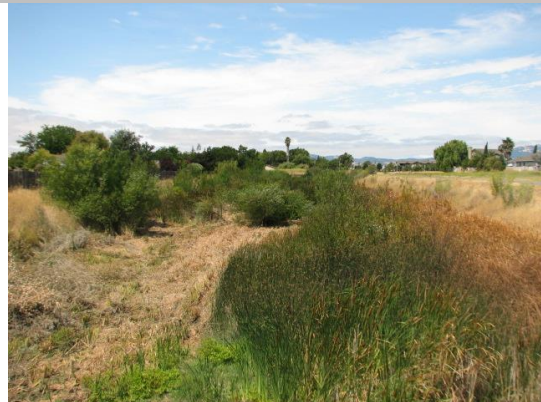
Photo 3 of 3 : CH\_2015\_NA0035\_15\_71\_20150612\_00037.jpg

Looking upstream from Blossom Rd. Summer 2014

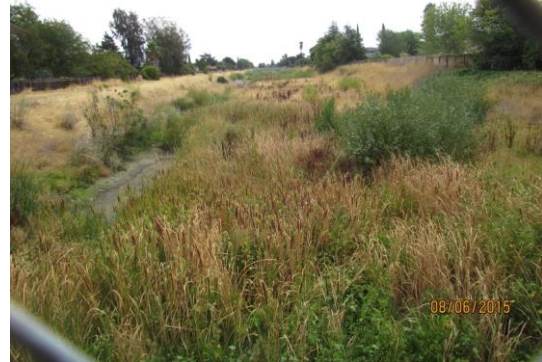
Photo 1 of 2 : CH\_2015\_NA0035\_15\_76\_20150817\_00069.jpg

Rating **	M	Issue No.	76	GPS Lat/Long
Issue Type +	Ma	Location *		38.253325 °
Category	Rivers, Channels & Designated Flood			-122.014818 °
Item	Vegetation & Obstructions			
DWR ID	DWR_NA0035_15_c _ 2012_76			
Action/Comments				
Inspector Comments: Log jams, snags, vegetation growth (such as cat tails, bull rushes, bushes or saplings) or other obstructions block approximately 25% of the capacity.

Looking downstream from Blossom Rd. Suggest removal of woody vegetation. Summer 2015.

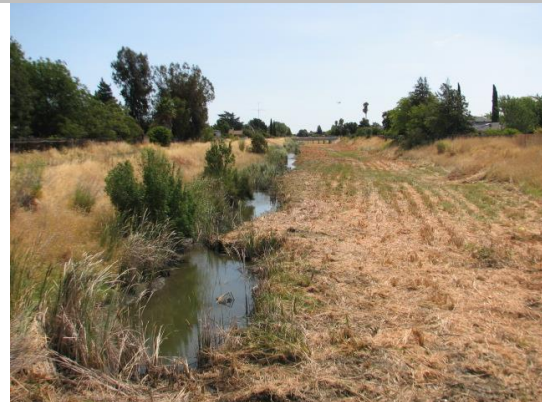
Photo 2 of 2 : CH\_2015\_NA0035\_15\_76\_20150612\_00039.jpg

Looking downstream from Blossom Rd. Summer 2014

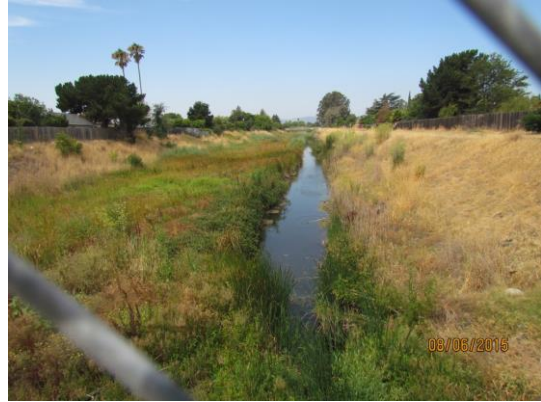
Photo 1 of 2 : CH\_2015\_NA0035\_15\_81\_20150817\_00070.jpg

Rating **	A	Issue No.	81	GPS Lat/Long
Issue Type +	Ma	Location *		38.253311 °
Category	Rivers, Channels & Designated Flood			-122.009841 °
Item	Vegetation & Obstructions			
DWR ID	DWR_NA0035_15_c _ 2012_81			
Action/Comments				
Inspector Comments: Minimal scattered obstructions or vegetation. The flow is not impeded.

Looking upstream from Worley Rd. Summer 2015.

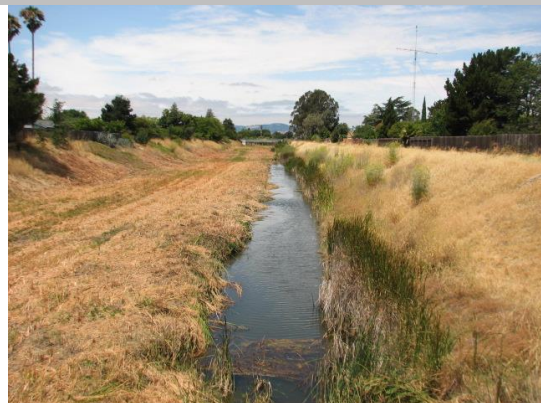
Photo 2 of 2 : CH\_2015\_NA0035\_15\_81\_20150612\_00041.jpg

A view looking upstream from Worley Rd. Summer 2014

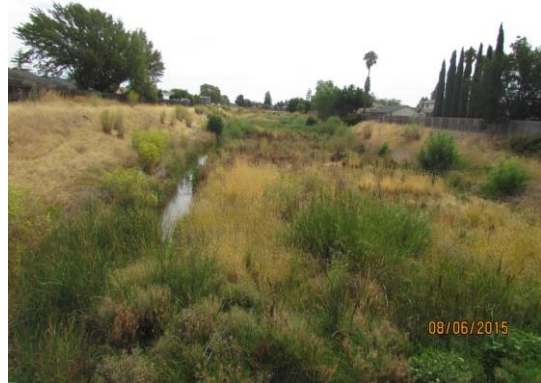
Photo 1 of 2 : CH\_2015\_NA0035\_15\_86\_20150817\_00071.jpg

Rating **	M	Issue No.	86	GPS Lat/Long
Issue Type +	Ma	Location *		38.253311
Category	Rivers, Channels & Designated Flood			-122.009841
Item	Vegetation & Obstructions			
DWR ID	DWR_NA0035_15_c _ 2012_86			
Action/Comments				
Inspector Comments: Vegetation growth (such as cat tails, bull rushes, bushes or saplings) or other obstructions block approximately 50% of the FCW.

Looking downstream from Worley Road. Suggest removal of woody vegetation. Summer 2015.

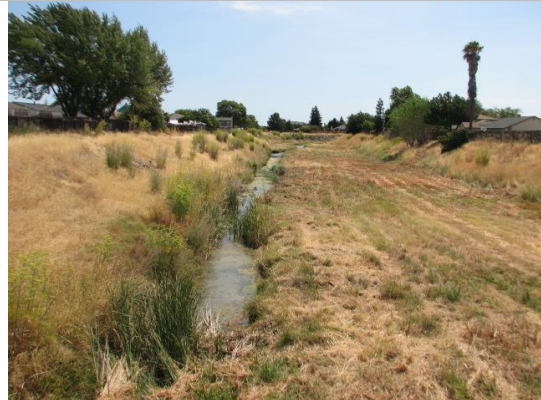
Photo 2 of 2 : CH\_2015\_NA0035\_15\_86\_20150612\_00043.jpg

A view looking downstream from Worley Rd. Summer 2014

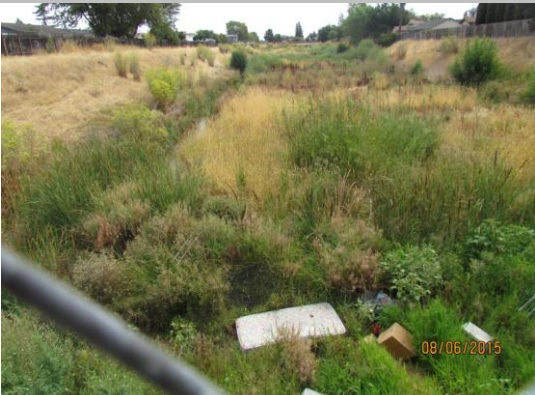
Photo 1 of 2 : CH\_2015\_NA0035\_15\_90\_20150817\_00073.jpg

Rating **	M	Issue No.	90	GPS Lat/Long
Issue Type +	Ma	Location *		38.253248 °
Category	Rivers, Channels & Designated Flood			-122.009732 °
Item	Encroachments			
DWR ID	DWR_NA0035_15_c _ 2012_90			
Action/Comments				
Inspector Comments: Trash and few obstructions were present within the project easement area.

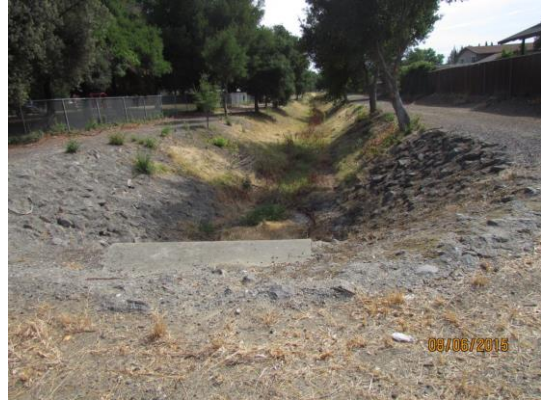
Photo 1 of 2 : CH\_2015\_NA0035\_17\_1\_20150817\_00053.jpg

Rating **	A	Issue No.	1	GPS Lat/Long
Issue Type +	Ma	Location *		38.256296 °
Category	Rivers, Channels & Designated Flood			-122.073705 °
Item	Vegetation & Obstructions			
DWR ID	DWR_NA0035_17_c _ 2012_1			
Action/Comments				
Inspector Comments: Minimal, scattered obstructions or vegetation.

Looking upstream from Astoria Dr. Trees have been trimmed. Summer 2015.

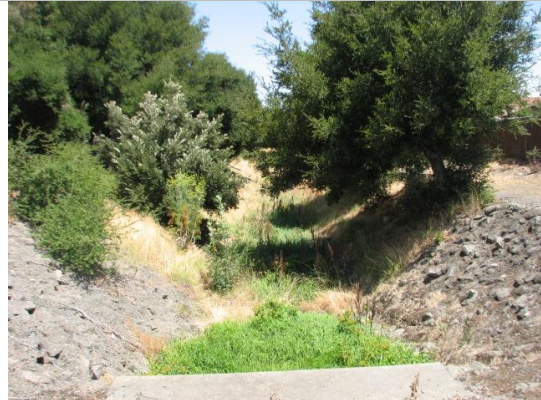
Photo 2 of 2 : CH\_2015\_NA0035\_17\_1\_20150612\_00002.jpg

Looking upstream from Astoria Dr. Trees need to be trimmed up or removed from channel. Summer 2014

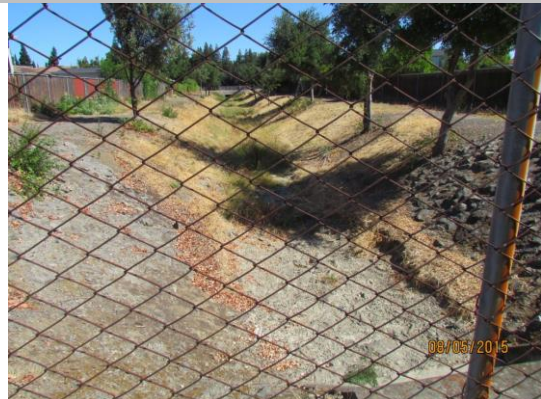
Photo 1 of 2 : CH\_2015\_NA0035\_17\_11\_20150817\_00055.jpg

Check Point / View				
Springfield Dr. / Up				
Rating **	A	Issue No.	11	GPS Lat/Long
Issue Type +	Ma	Location *		38.254594
Category	Rivers, Channels & Designated Flood			-122.073608
Item	Vegetation & Obstructions			
DWR ID	DWR_NA0035_17_c _ 2012_11			
Action/Comments				
Inspector Comments: Minimal, scattered obstructions or vegetation. The flow is not impeded.

Looking upstream from Springfield Dr. Summer 2015.

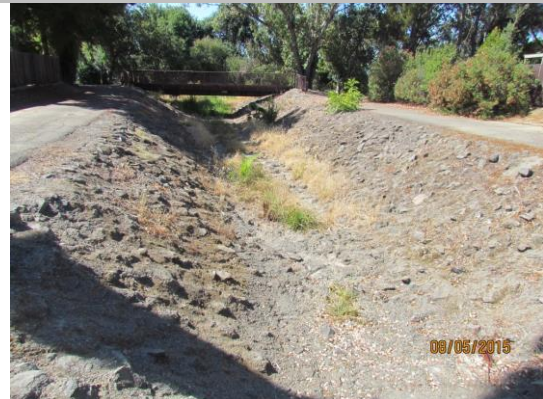
Photo 1 of 2 : CH\_2015\_NA0035\_17\_16\_20150817\_00056.jpg

Check Point / View				
Springfield Dr. / Down				
Rating **	A	Issue No.	16	GPS Lat/Long
Issue Type +	Ma	Location *		38.254594
Category	Rivers, Channels & Designated Flood			-122.073608
Item	Vegetation & Obstructions			
DWR ID	DWR_NA0035_17_c _ 2012_16			
Action/Comments				
Inspector Comments: Minimal, scattered obstructions or vegetation. The flow is not impeded.

Looking downstream from Springfield Dr. Summer 2015.

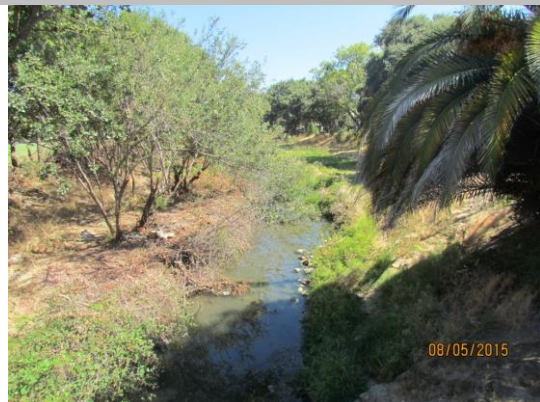
Photo 1 of 2 : CH\_2015\_NA0035\_17\_21\_20150817\_00057.jpg

Inspector Comments: Minimal, scattered obstructions or vegetation. The flow is not impeded.

Looking upstream from Rockville Rd. Summer 2015.

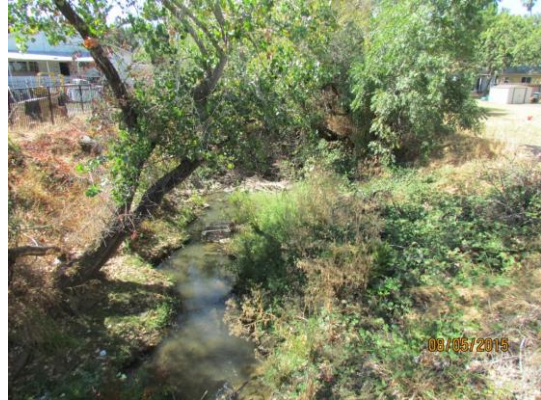
Photo 1 of 2 : CH\_2015\_NA0035\_17\_26\_20150817\_00058.jpg

Rating **	A	Issue No.	26	GPS Lat/Long
Issue Type +	Ma	Location *		38.249840 °
Category	Rivers, Channels & Designated Flood			-122.072644 °
Item	Vegetation & Obstructions			
DWR ID	DWR_NA0035_17_c_2012_26			
Action/Comments				
Inspector Comments: Minimal, scattered obstructions or vegetation. The flow is not impeded.

Looking downstream from Rockville Rd. Summer 2015.

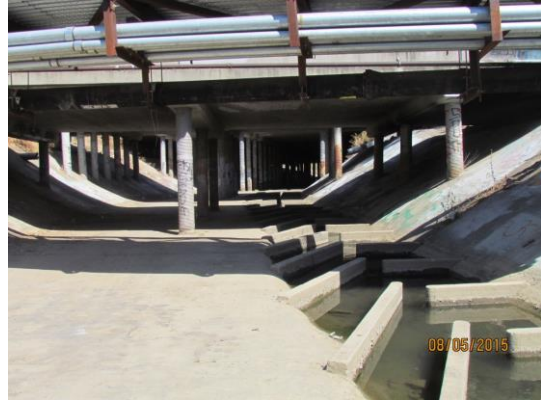
Photo 1 of 2 : CH\_2015\_NA0035\_17\_31\_20150817\_00059.jpg

Inspector Comments: Minimal, scattered obstructions or vegetation. The flow is not impeded.

Looking upstream from Auto Mall Pkwy under I-80. Summer 2015.

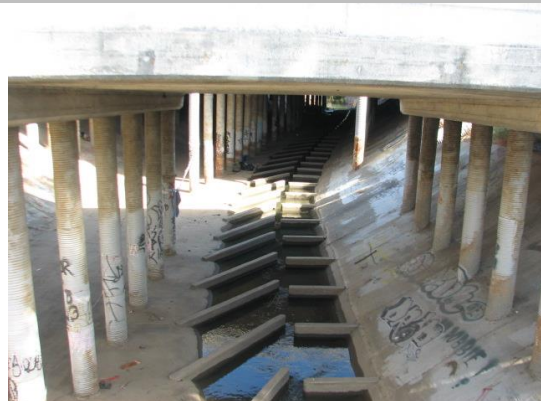
Photo 2 of 2 : CH\_2015\_NA0035\_17\_31\_20150612\_00020.jpg

Upstream view from Auto Mall Pkwy. Under I-80 and homeless camp. Summer 2014

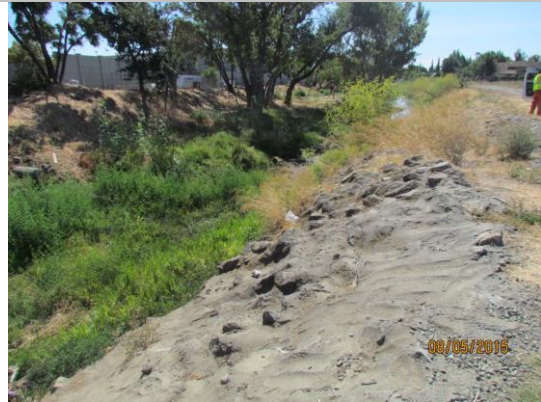
Photo 1 of 2 : CH\_2015\_NA0035\_17\_36\_20150817\_00062.jpg

Inspector Comments: Minimal, scattered obstructions or vegetation. The flow is not impeded.

Looking downstream from Auto Mall Pkwy. Summer 2015.

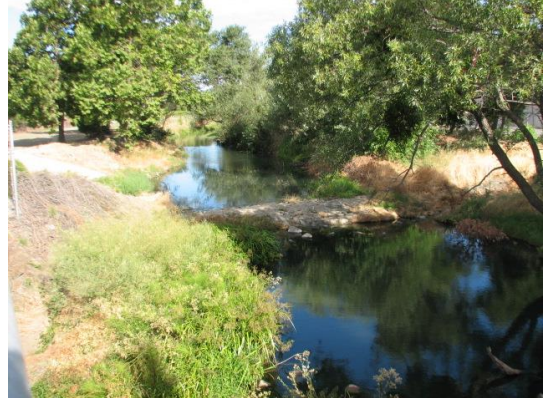
Photo 2 of 3 : CH\_2015\_NA0035\_17\_41\_20150612\_00027.jpg

Inspector Comments: Minimal, scattered obstructions or vegetation. The flow is not impeded.

A view looking upstream from Woolner Ave. Summer 2014

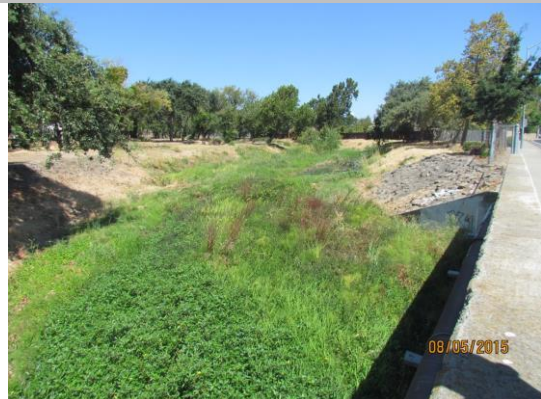
Photo 1 of 3 : CH\_2015\_NA0035\_17\_51\_20150817\_00065.jpg

Inspector Comments: Minimal, scattered obstructions or vegetation. The flow is not impeded.

Looking upstream from Beck Ave. Summer 2015.

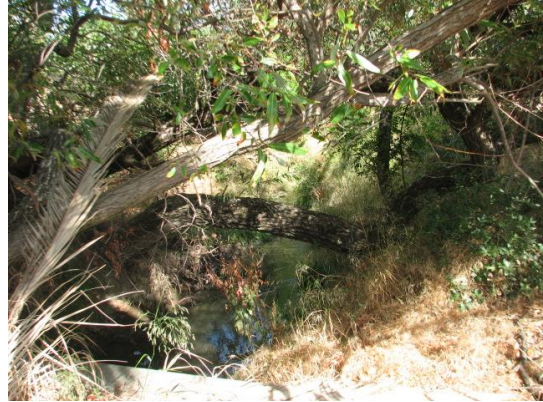
Photo 3 of 3 : CH\_2015\_NA0035\_17\_51\_20150612\_00034.jpg

Inspector Comments: Minimal, scattered obstructions or vegetation. The flow is not impeded.

Upstream view of the historical channel from Beck Ave. Summer 2014

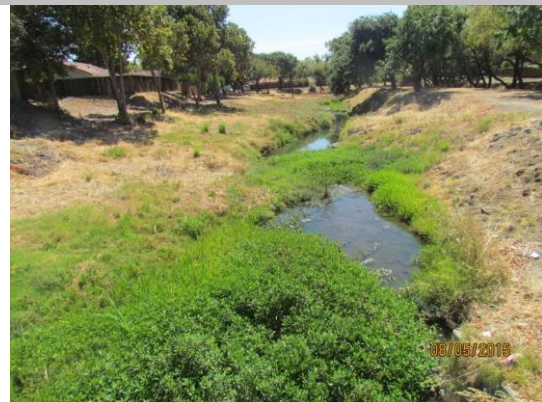
Photo 1 of 3 : CH\_2015\_NA0035\_17\_56\_20150817\_00066.jpg

Inspector Comments: Minimal, scattered obstructions or vegetation. The flow is not impeded.

Looking downstream from Beck Ave. Summer 2015.

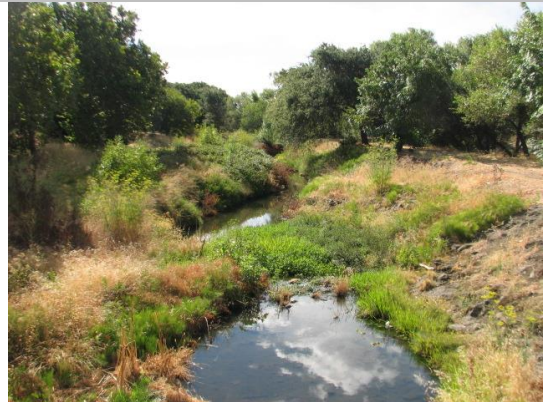
Photo 2 of 3 : CH\_2015\_NA0035\_17\_56\_20150612\_00038.jpg

Inspector Comments: Minimal, scattered obstructions or vegetation. The flow is not impeded.

Downstream view of the main channel from Beck Ave. Summer 2014

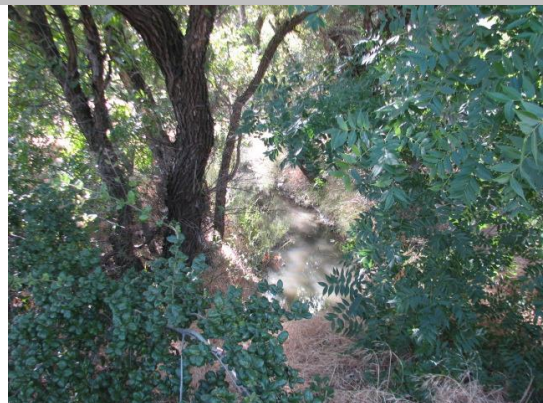
Photo 3 of 3 : CH\_2015\_NA0035\_17\_56\_20150612\_00039.jpg

The historical channel from Beck Ave. looking downstream. Summer 2014

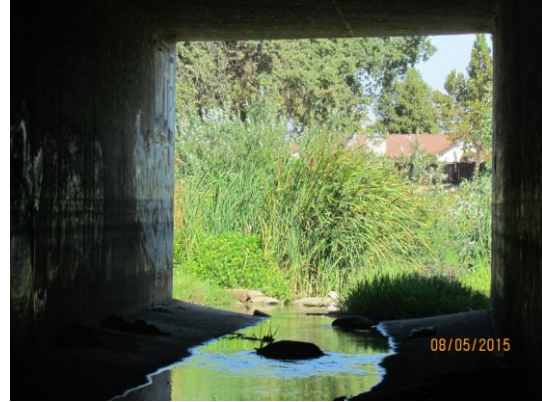
Photo 1 of 3 : CH\_2015\_NA0035\_17\_61\_20150817\_00067.jpg

Looking upstream from Highway 12. Summer 2015.

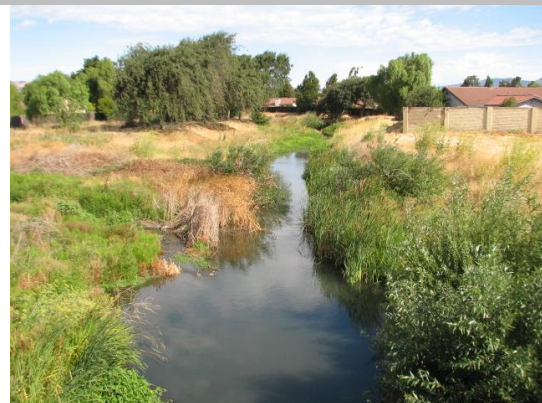
Photo 2 of 3 : CH\_2015\_NA0035\_17\_61\_20150612\_00043.jpg

Upstream view of the main channel from Highway 12. Summer 2014

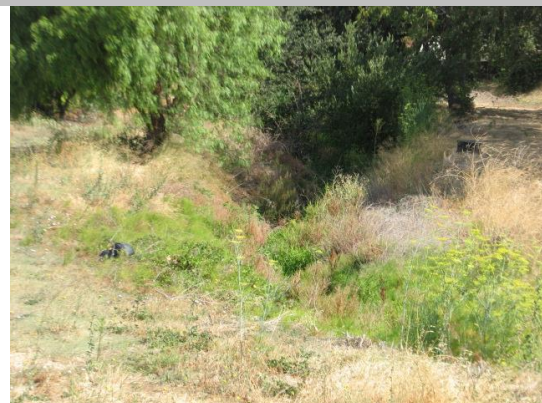
Photo 3 of 3 : CH\_2015\_NA0035\_17\_61\_20150612\_00042.jpg

The outlet of the historical channel looking upstream from Highway 12. Summer 2014

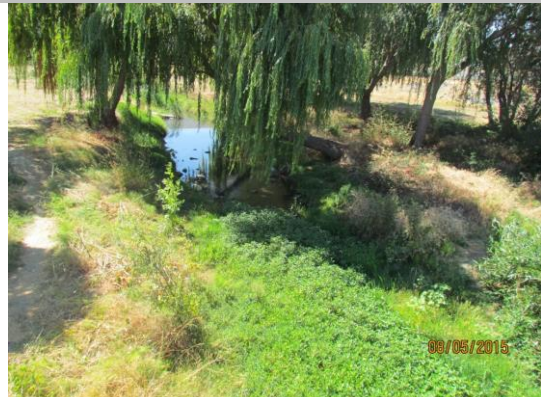
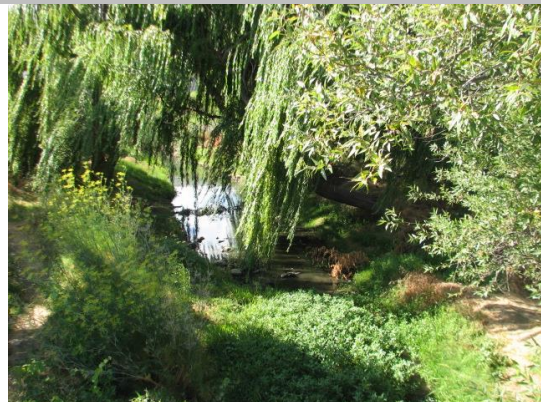
Inspector Comments: Minimal, scattered obstructions or vegetation. The flow is not impeded.

Looking downstream from Highway 12. Summer 2015.

Looking downstream from Highway 12. Summer 2014

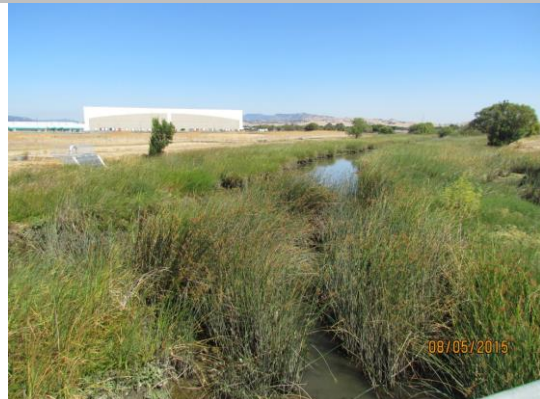
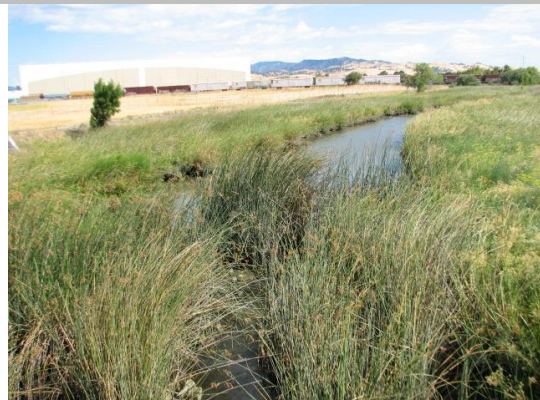
Inspector Comments: Vegetation growth of cattails or other obstruction impede the flow.

Looking upstream from Cordelia Rd. Summer 2015.

An upstream view of the channel from Cordelia Rd. Summer 2014

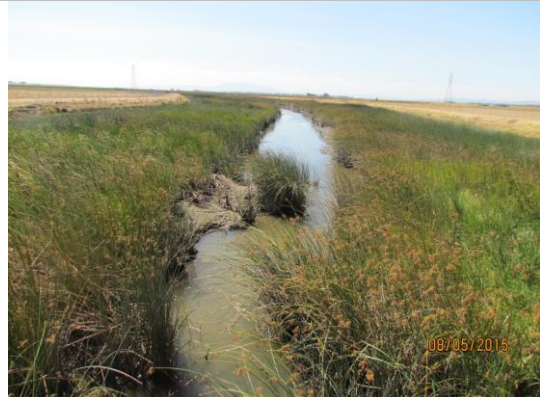
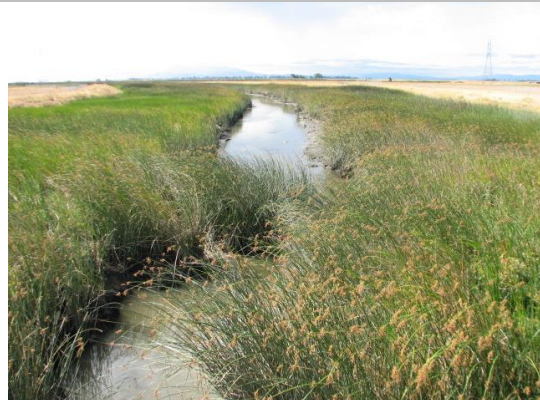
Inspector Comments: Minimal, scattered obstructions or vegetation. The flow is not impeded.

Looking downstream from Cordelia Rd. Summer 2015.

A downstream view of the channel from Cordelia Rd. Summer 2014

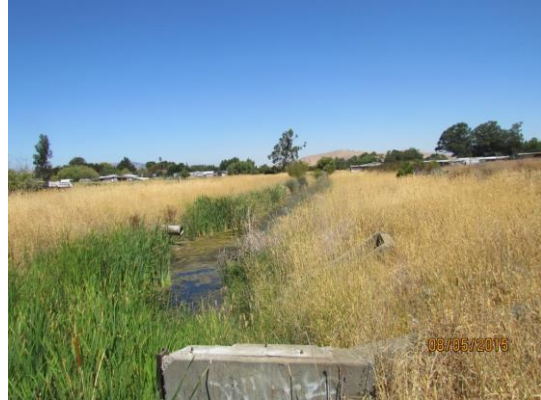
Photo 1 of 2 : CH\_2015\_NA0035\_14\_1\_20150817\_00023.jpg

Inspector Comments: Minimal, scattered obstructions or vegetation. The flow is not impeded.

View of the vegetation looking upstream of the channel. Summer 2015.

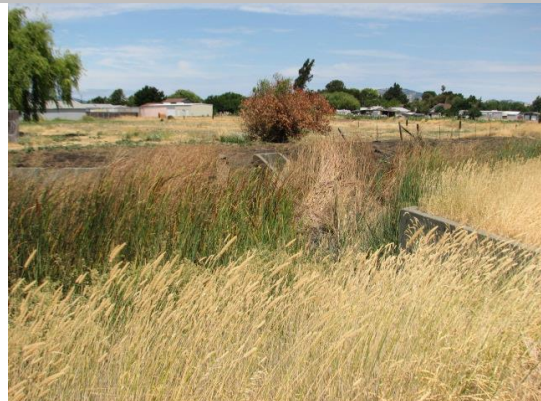
Photo 2 of 2 : CH\_2015\_NA0035\_14\_1\_20150612\_00002.jpg

Control structure is blocked by cattails. Remove or spray vegetation to open structure. Summer 2014

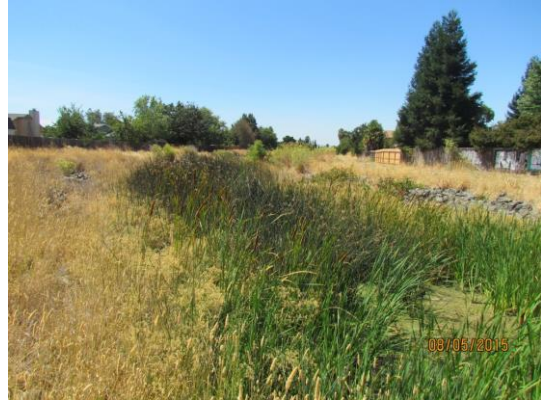
Photo 1 of 2 : CH\_2015\_NA0035\_14\_6\_20150817\_00025.jpg

Inspector Comments: Vegetation growth (such as cat tails, bull rushes, bushes or saplings) or other obstructions block approximately 25% of the capacity.

View of the vegetation looking downstream. Summer 2015.

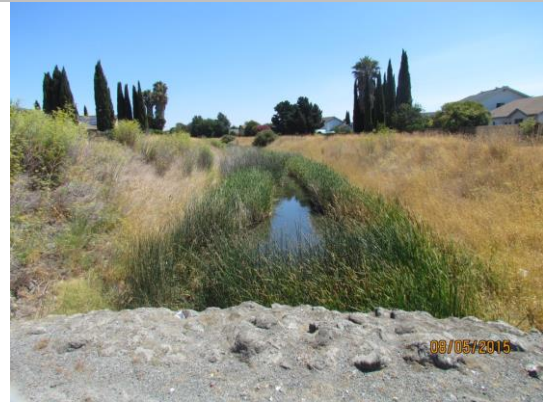
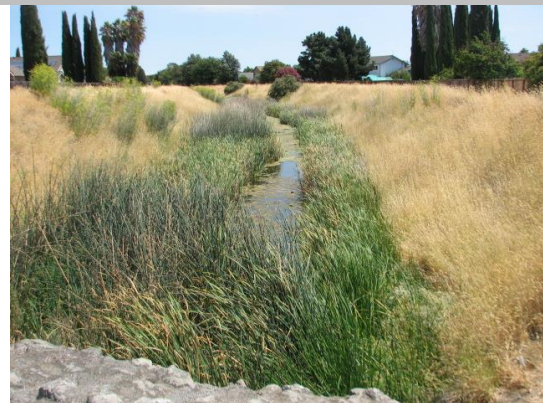
Inspector Comments: Cat-tails need to be sprayed or removed at street crossing.

View of the channel looking upstream. Summer 2015.

A view looking upstream from Emperor Dr. Summer 2014

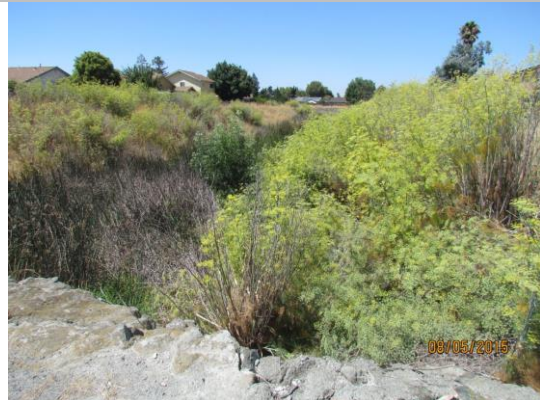
Photo 1 of 3 : CH\_2015\_NA0035\_14\_16\_20150817\_00028.jpg

Woody vegetation looking downstream. Suggest removal of woody vegetation. Summer 2015.

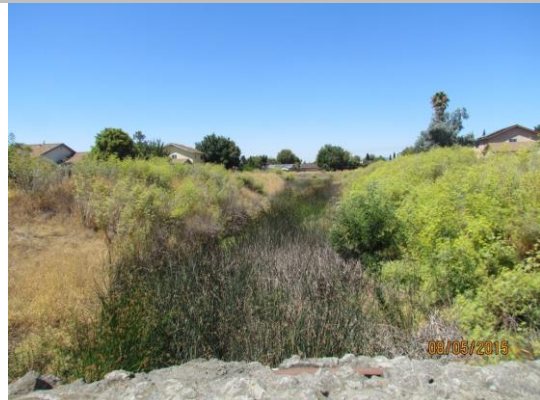
Photo 2 of 3 : CH\_2015\_NA0035\_14\_16\_20150817\_00027.jpg

View of the vegetation looking downstream. Summer 2015.

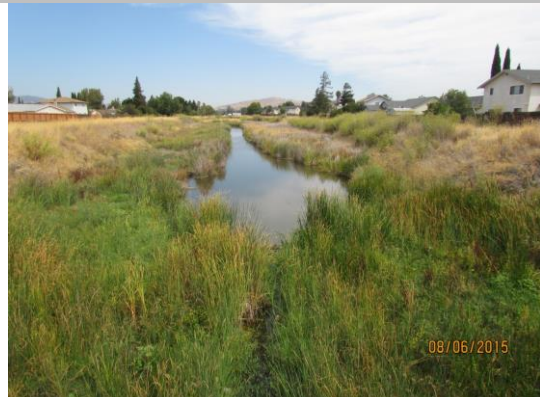
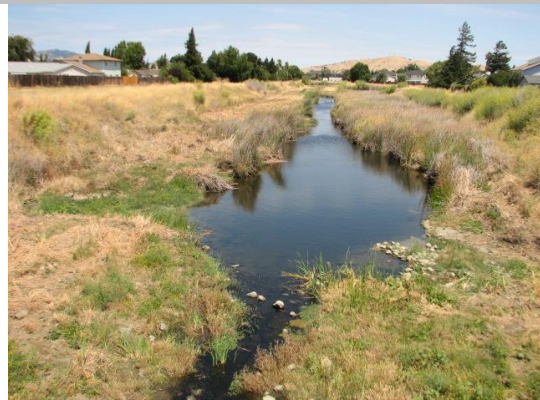
Check Point / View				
Pintail Ave / Up				
Rating **	A	Issue No.	21	GPS Lat/Long
Issue Type +	Ma	Location *		38.248501
Category	Rivers, Channels & Designated Flood			-122.006344
Item	Vegetation & Obstructions			
DWR ID	DWR_NA0035_14_c _ 2012_21			
Action/Comments				
Inspector Comments: Minimal scattered obstruction or vegetation. The flow is not impeded. Watch out for the vegetation growing.

View of the channel looking upstream. Summer 2015.

A view looking upstream from Pintail Dr. Summer 2014

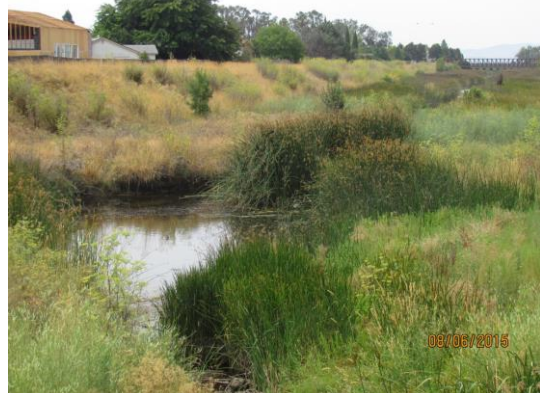
Photo 1 of 3 : CH\_2015\_NA0035\_14\_26\_20150817\_00031.jpg

Inspector Comments: Log jams, snags, vegetation growth (such as cat tails, bull rushes, bushes or saplings) or other obstructions block approximately 25% of the FCW.

Suggest removal of tullies downstream. Summer 2015.

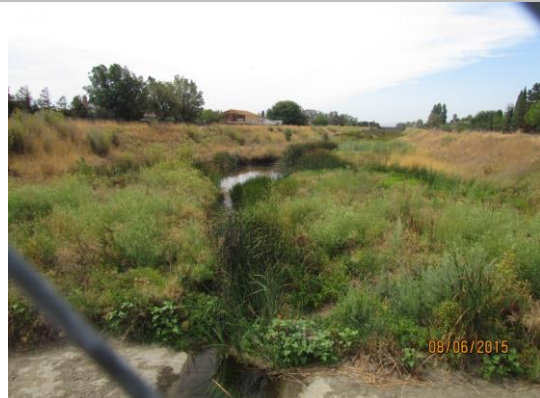
Photo 2 of 3 : CH\_2015\_NA0035\_14\_26\_20150817\_00030.jpg

View of the channel looking downstream. Summer 2015.

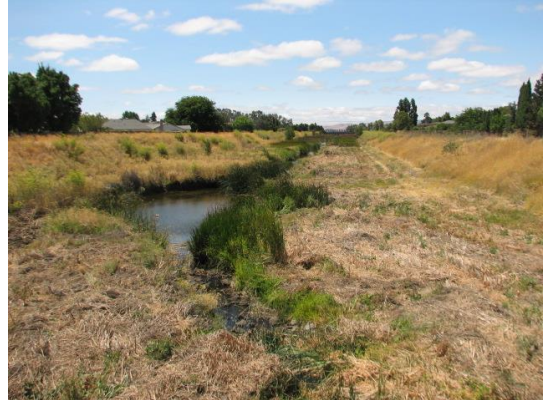
Photo 3 of 3 : CH\_2015\_NA0035\_14\_26\_20150612\_00017.jpg

Inspector Comments: Log jams, snags, vegetation growth (such as cat tails, bull rushes, bushes or saplings) or other obstructions block approximately 25% of the FCW.

A view looking downstream from Pintail Dr. Summer 2014

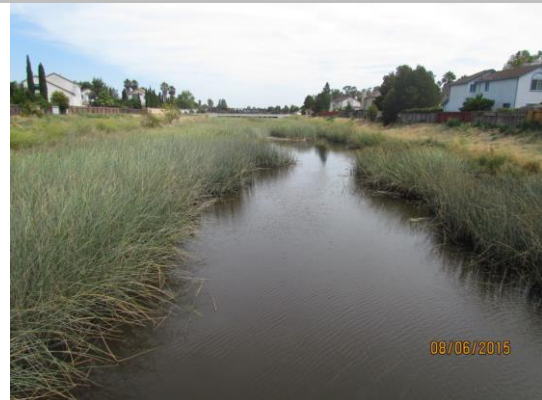
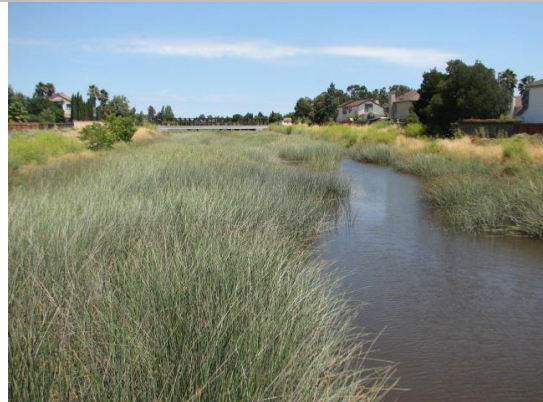
Inspector Comments: Vegetation growth (such as cat tails, bull rushes, bushes or saplings) or other obstructions block approximately 25% of the FCW.

View of the channel looking upstream. Summer 2015.

Rating **	M	Issue No.	31 (cont)	GPS Lat/Long
Issue Type +	Ma	Location *		38.241537 °
Category	Rivers, Channels & Designated Flood			-122.012077 °
Item	Vegetation & Obstructions			
DWR ID	DWR_NA0035_14_c _ 2012_31			
Action/Comments				
Inspector Comments: Vegetation growth (such as cat tails, bull rushes, bushes or saplings) or other obstructions block approximately 25% of the FCW.

Looking upstream from Anderson Dr. towards Highway 12. Summer 2014

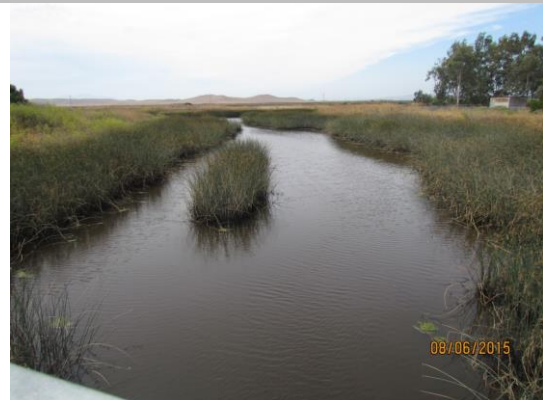
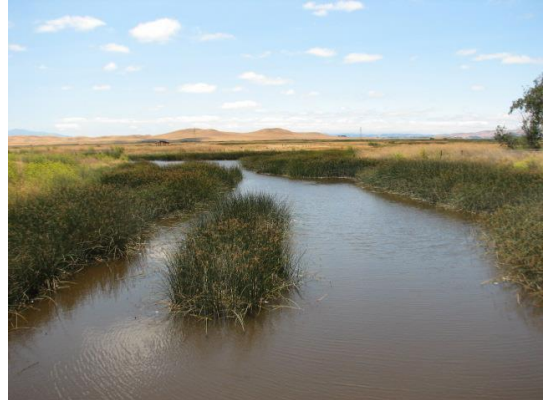
Inspector Comments: Minimal, scattered obstructions or vegetation. The flow is not impeded.

View of the channel looking downstream. Summer 2015.

Rating **	A	Issue No.	36 (cont)	GPS Lat/Long
Issue Type +	Ma	Location *		38.241537 °
Category	Rivers, Channels & Designated Flood			-122.012077 °
Item	Vegetation & Obstructions			
DWR ID	DWR_NA0035_14_c_2012_36			
Action/Comments				
Inspector Comments: Minimal, scattered obstructions or vegetation. The flow is not impeded.

Looking downstream towards Suisun Bay from Anderson Dr. Summer 2014

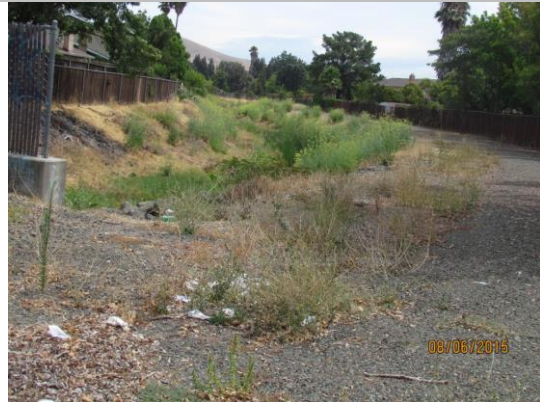
Photo 1 of 3 : CH\_2015\_NA0035\_16\_6\_20150817\_00016.jpg

Looking downstream from N. Texas St. Summer 2015.

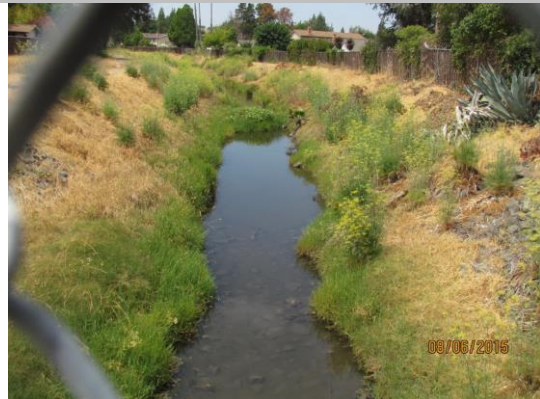
Photo 1 of 3 : CH\_2015\_NA0035\_16\_11\_20150817\_00017.jpg

Check Point / View				
Camrose Ave / Up				
Rating **	A	Issue No.	11	GPS Lat/Long
Issue Type +	Ma	Location *		38.281544
Category	Rivers, Channels & Designated Flood			-122.030546
Item	Vegetation & Obstructions			
DWR ID	DWR_NA0035_16_c _ 2012_11			
Action/Comments				
Inspector Comments: Minimal, scattered obstructions or vegetation. The flow is not impeded.

Looking upstream from Camrose Ave. Summer 2015.

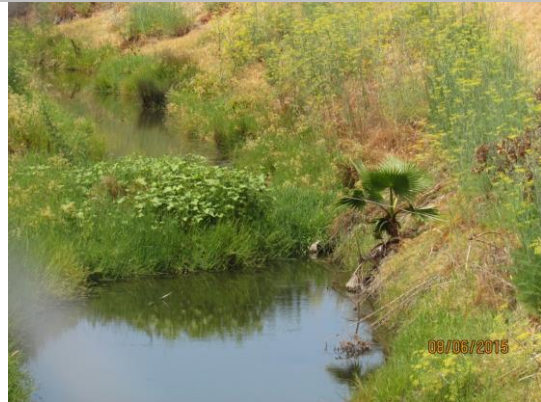
Photo 2 of 3 : CH\_2015\_NA0035\_16\_11\_20150817\_00018.jpg

Suggest removal of palm tree before it grows looking upstream from Camrose Ave. Summer 2015.

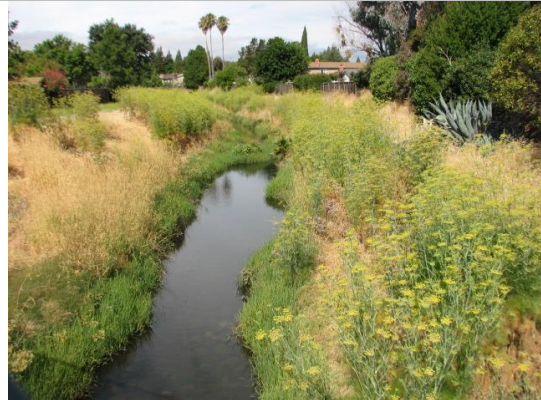
Photo 3 of 3 : CH\_2015\_NA0035\_16\_11\_20150612\_00004.jpg

Looking upstream from Camrose Ave. Summer 2014
